Green Lick Dam (NDI PA-219), Ohio River
Basin, Green Lick Run, Fayette County,
Pennsylvania. Phase I Inspection Report.

PHASE I REPORT
National Dam Inspection Program

Green Lick Dam

27 April 1978 (visual inspection)

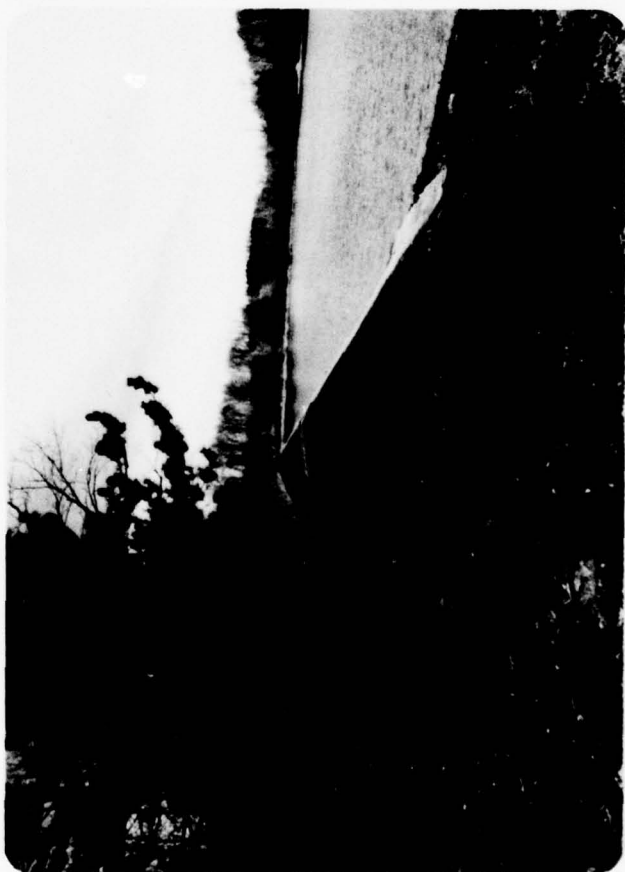
PHOTOGRAPHS 1, View looking across the top of the Green
1a Lick Dam embankment as it appeared in 1926
(1) and as it appears today (1a). The
upstream portion of the embankment is covered
with a masonry face which extends below the
water level.

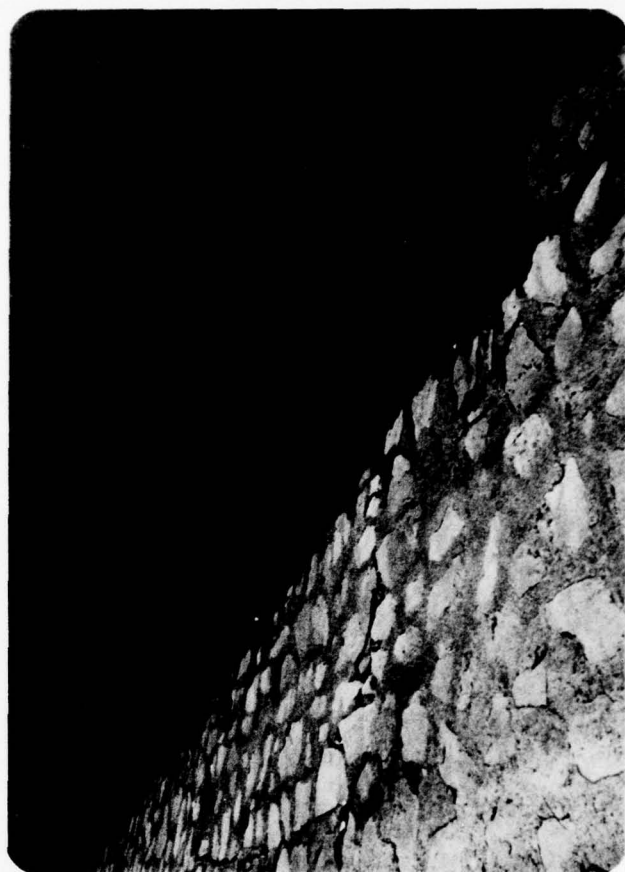
The upstream surface has been covered with a mortared masonry face and cutoff wall, probably to reduce seepage through the embankment. Field inspection, however, showed the surface to contain at least one longitudinal crack two to three feet above the present water level and a regular pattern of vertical cracks spaced at 25 to 35-foot centers across the face. Thus, the facing is ineffective as a seepage barrier.

PHOTOGRAPH 2 Close-up view of the upstream face of Green
Lick Dam. Note the masonry construction.

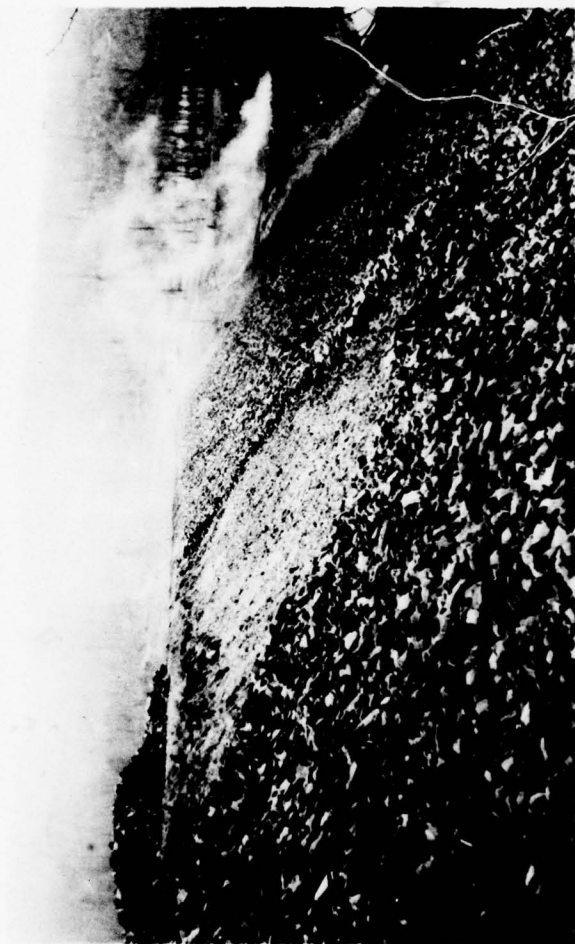
PHOTOGRAPHS 3, View looking across the downstream face of
3a the Green Lick Dam from the right abutment.
The gate house can be seen at the bottom of
the embankment. Photograph 3a is a similar
view of the embankment taken in 1920, showing
sloughing of the riprap face.

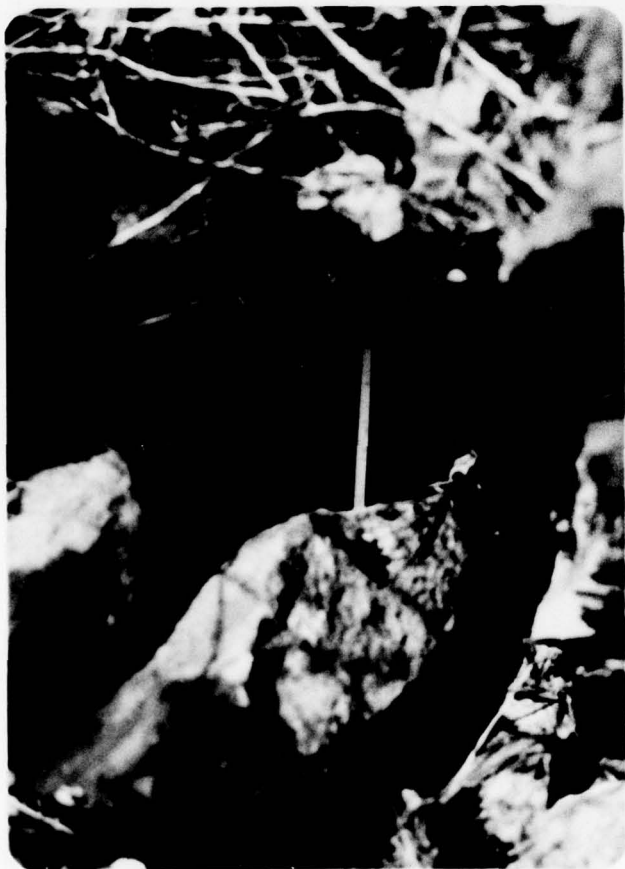
PHOTOGRAPH 6 Close-up view of another cavity in the downstream face of the Green Lick Dam embankment. We estimated the flow to be between five and ten gallons per minute at this point.

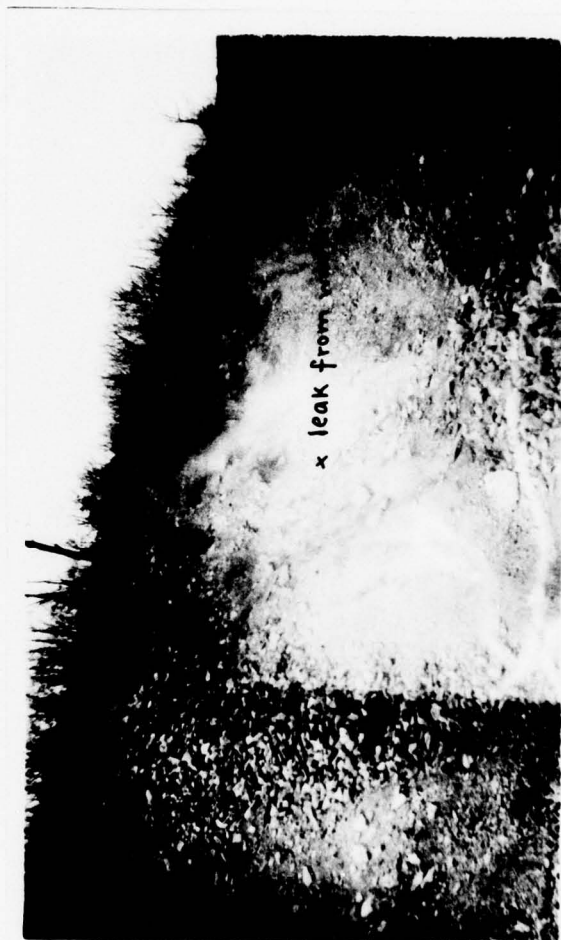
PHOTOGRAPHS 7, View of a large area of seepage on the right
7a abutment of the Green Lick embankment. At the time of inspection, the seepage at this point was estimated to be between five and ten gallons per minute. The spillway is immediately behind this area of seepage. Photograph 7a shows seepage issuing from the same area as it appeared in 1914.

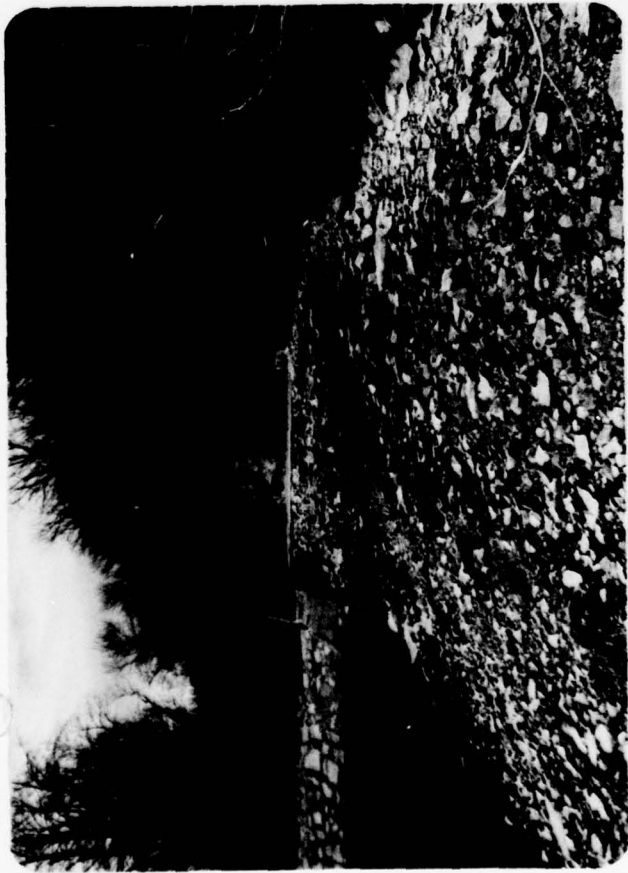
PHOTOGRAPHS 8, View looking downstream at the approach
8a channel to the Green Lick spillway as it
appears presently (8), and as it appeared in
1914 (8a).

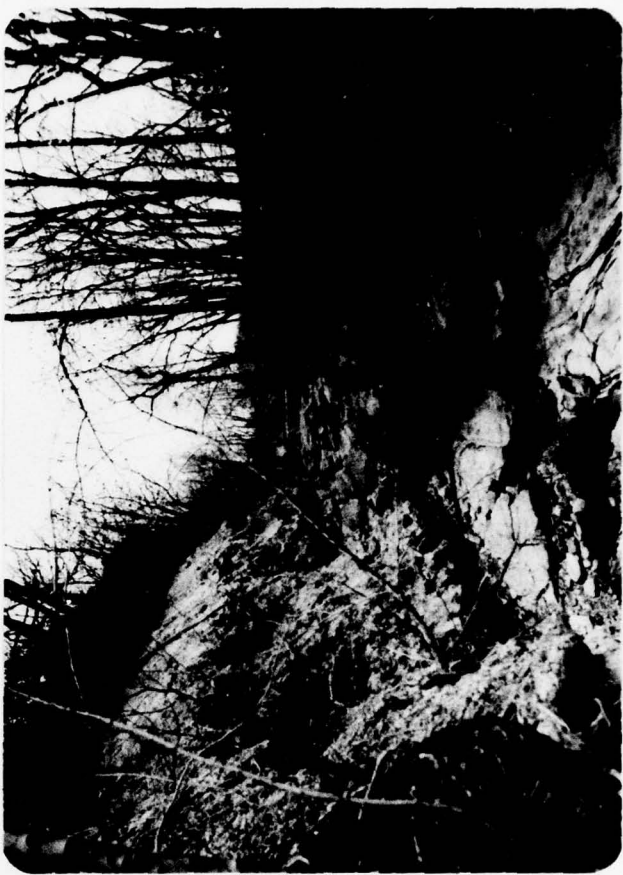
PHOTOGRAPH 10 View looking upstream from the natural rock
channel. The concrete portion of the spillway
can be seen in the background of the photo-
graph.

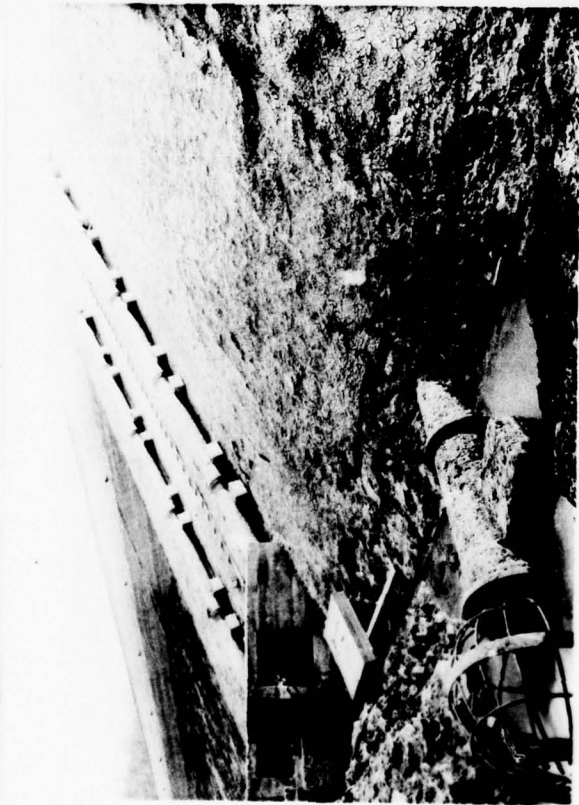
PHOTOGRAPH 14 View of the inlet end of the 24-inch blow-off pipe as it appeared in 1926.

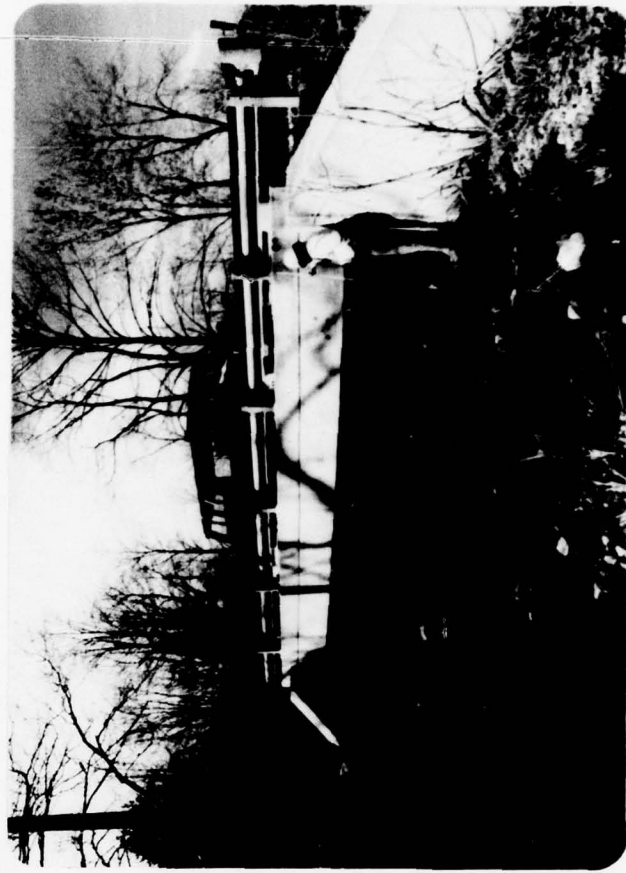
PHOTOGRAPH 17 View of a bridge over Latta Creek located approximately 3,000 feet downstream of the dam.
